What's next for the Skagit River Bridge?

Bridge & Structures Office
Skagit River Bridge Emergency

Bridge collapse incident

Bridge builders innovate

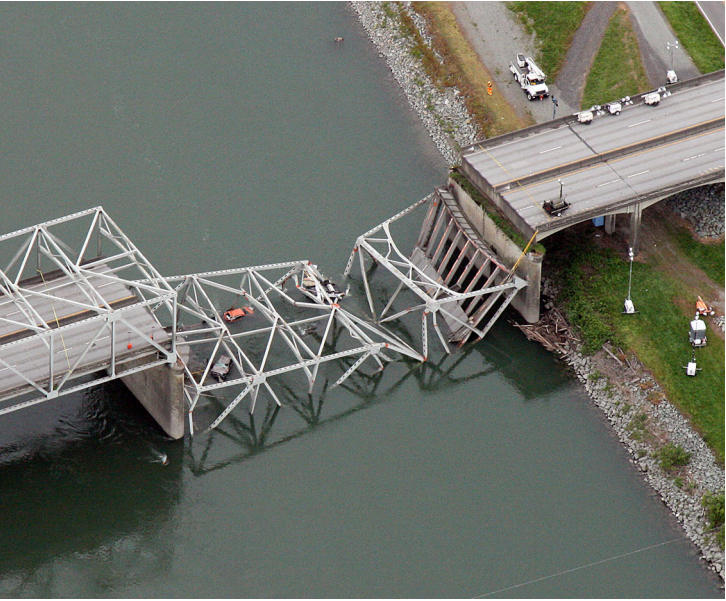
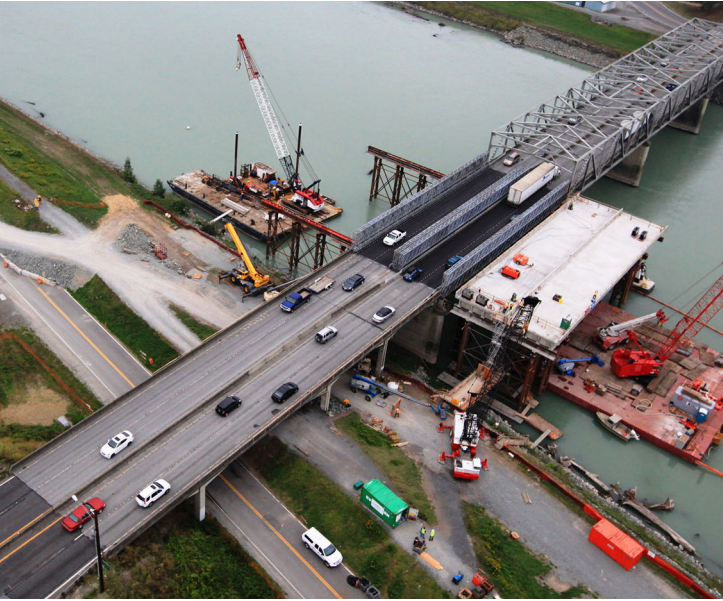
On May 23, 2013 the evening commute was just ending along a four-lane stretch of the Interstate 5 corridor, which lies between the Canadian Border and Seattle. At roughly 7 p.m., a semitruck heading southbound and carrying a permitted oversized-load struck the first portal and several subsequent sway members along the steel truss section of the bridge. The northern truss span of the bridge collapsed into the Skagit River.

While the semi-truck made it across hitting several more sway frames along the way, several vehicles didn't and the occupants had to be rescued. No one was killed in the collapse.

Within 24 hours a contractor was hired under an emergency contract to remove the collapsed span, and began working with WSDOT engineers to install a temporary span to get the Interstate back open. As the work was being done to temporarily restore I-5 traffic, WSDOT engineers began assembling contract documents for a permanent span repair.
